## Keeping you up-to-date

## Safety & Maintenance of Portable Electrical Equipment

## A Network Nightmare

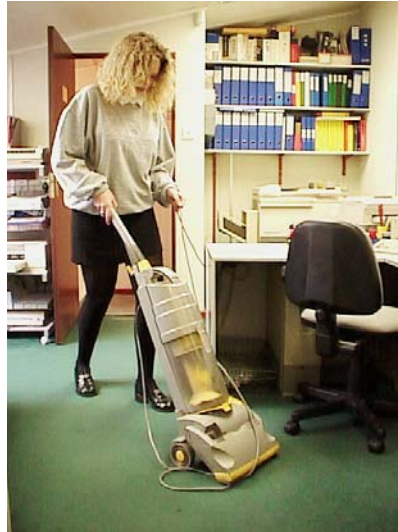
In one days use, the vacuum cleaner lead is pulled around the floor, trapped under doors, pulled around sharp edges on walls and often, run over by the cleaner, skinning the cable and then after use, it is wrapped and twisted around the body of the cleaner. Of all the damaged leads that we have seen, the worst have been on vacuum cleaners. Some of the leads we have seen look more like barber poles, covered in multi coloured insulating tape. The other problem is that often, due to the use of contract cleaners, the leads are never tested or inspected for use within your building. Whilst all the testing is going on, the vacuum cleaner is generally locked away, only to come out once the test gear has been long put away.

recommend that the plug on the cleaner be replaced with a plug fitted with an internal 30mA RCCD.

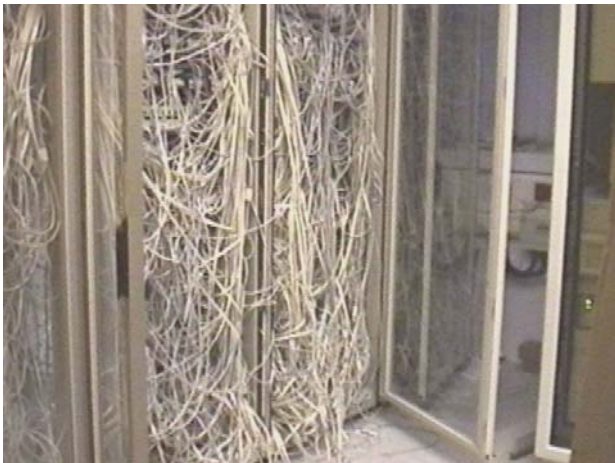
Due to moves and changes, the enclosures had become a real mess. The patch cables completely concealed the patch panels in all enclosures making any further alterations virtually impossible. The installation had completely out grown the cable management system supplied with the enclosures.

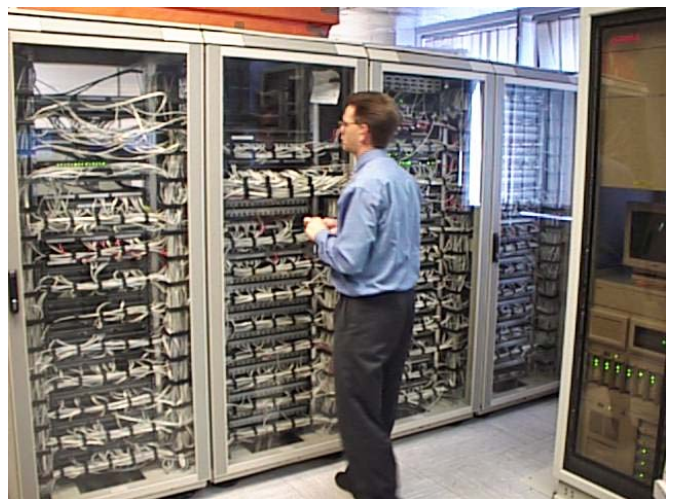
To prevent the same mess reoccurring, the cabinets are now locked and only authorised personnel are allowed to patch any services and the photograph above was taken 4 months after completion so it must be working!

The horizontal 'U' supports in each cabinet were unbolted and very carefully moved back with all of the patch panels in situ. Whilst carrying the works, we decided to move some of the more fixed services to the rear of the centre enclosure, mounted on new rails. This freed up around 20 'U' in one of the other cabinets, allowing for an imminent expansion in floor ports. Once this had been done, the new vertical cable management system was fitted over night and at around 3 o'clock Sunday afternoon we were ready to

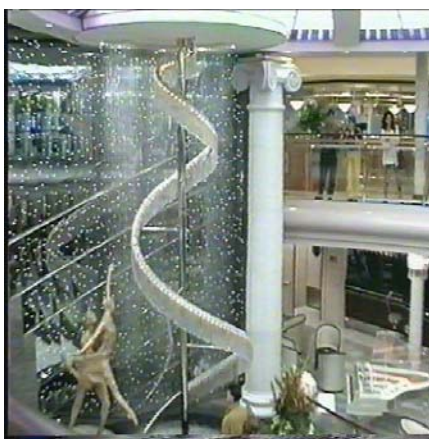
The control system for the Crystal Symphony seemed quite straight forward as their Managing Director had a very clear vision of how the feature was to operate. The feature consisted of 600 tiny laces which water flowed down, and 1,500 fibre optic pixels sparkling through the falling water. There were a number of tanks & pools which delivered and collected the water. With our knowledge of computer based control systems and electronic water sensors, we soon put a design together which would allow the feature to work at sea which was the more tricky part. The system was installed and was a complete success.

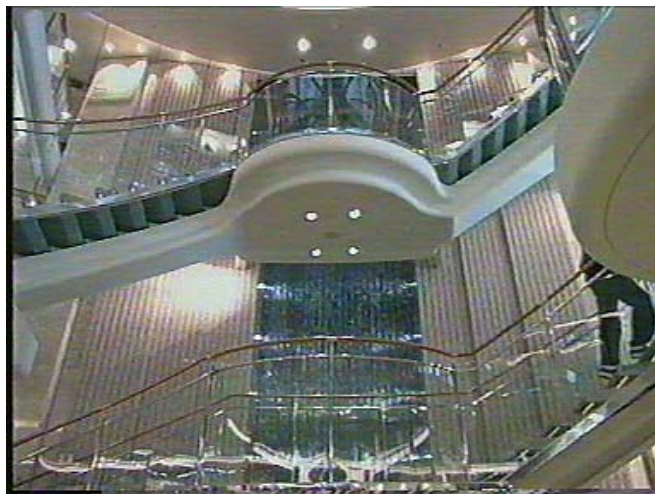
When the Oriana arrived at Southampton, ready for the naming, we all went on board to see the finished feature. It consisted of around 600 tiny laces, allowing the water to cascade down the four deck Atrium, some 50ft. Fibre optic lights shone through the laces down its length which made the water sparkle. It
